Microstructure analysis of a banded work roll

M. Dünckelmeyer, C. Kremaszky, E. Werner, G. Hein, K. Schörkhuber

Damage of rolls in a hot rolling strip mill

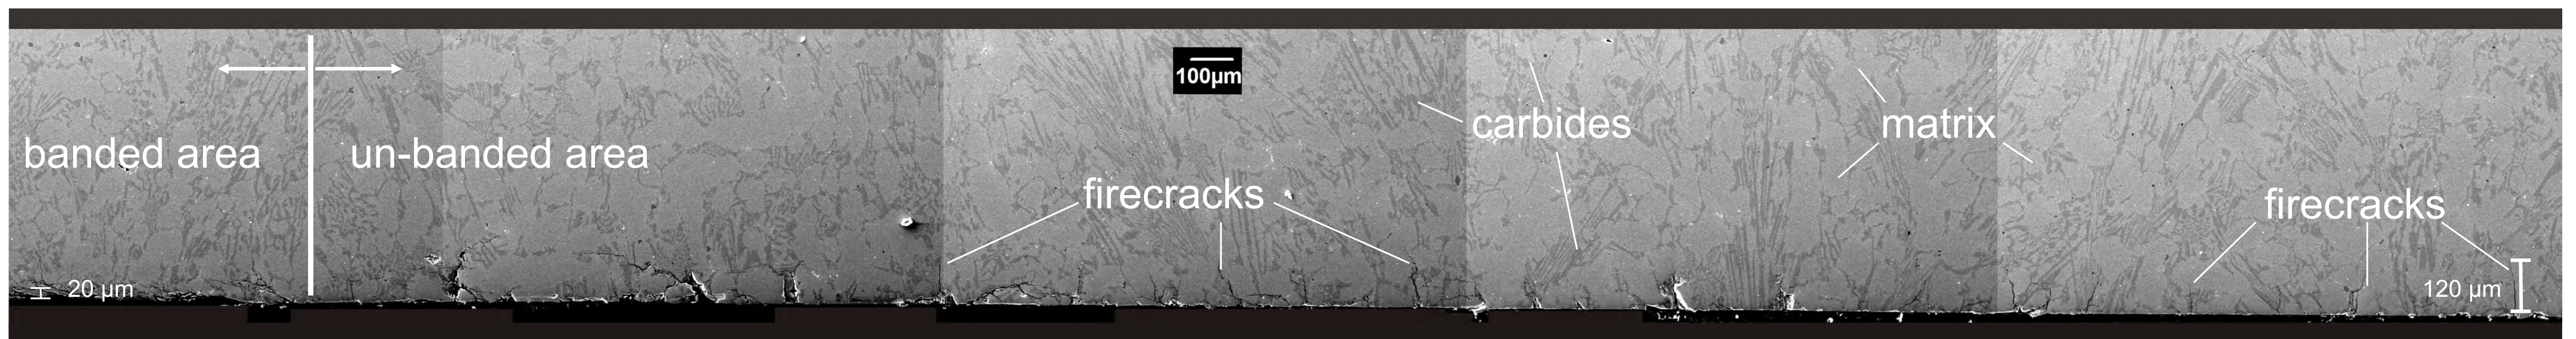
Damage of a work roll on an overview of transition between banded and un-banded area in lateral view, SEM

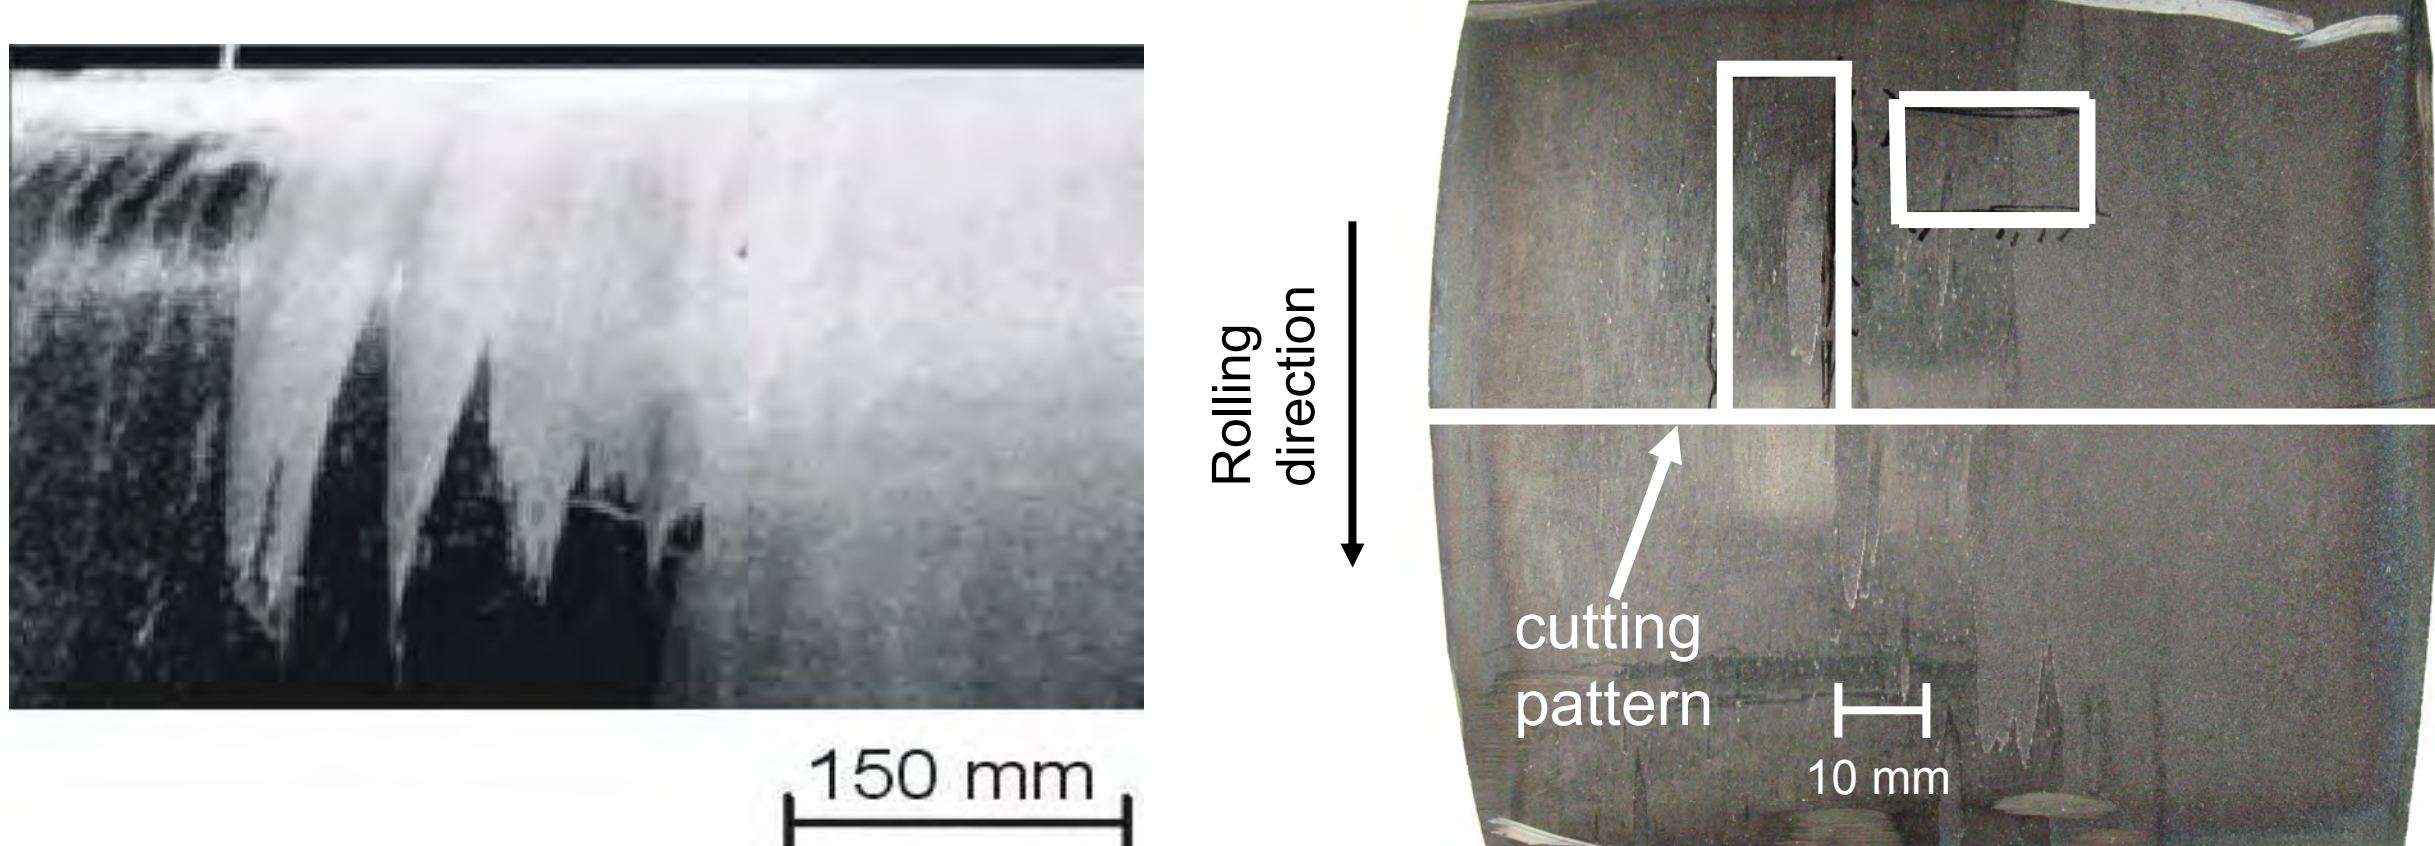
Surface damage of an industrially used work roll Investigated HiCr roll segment with banded surface

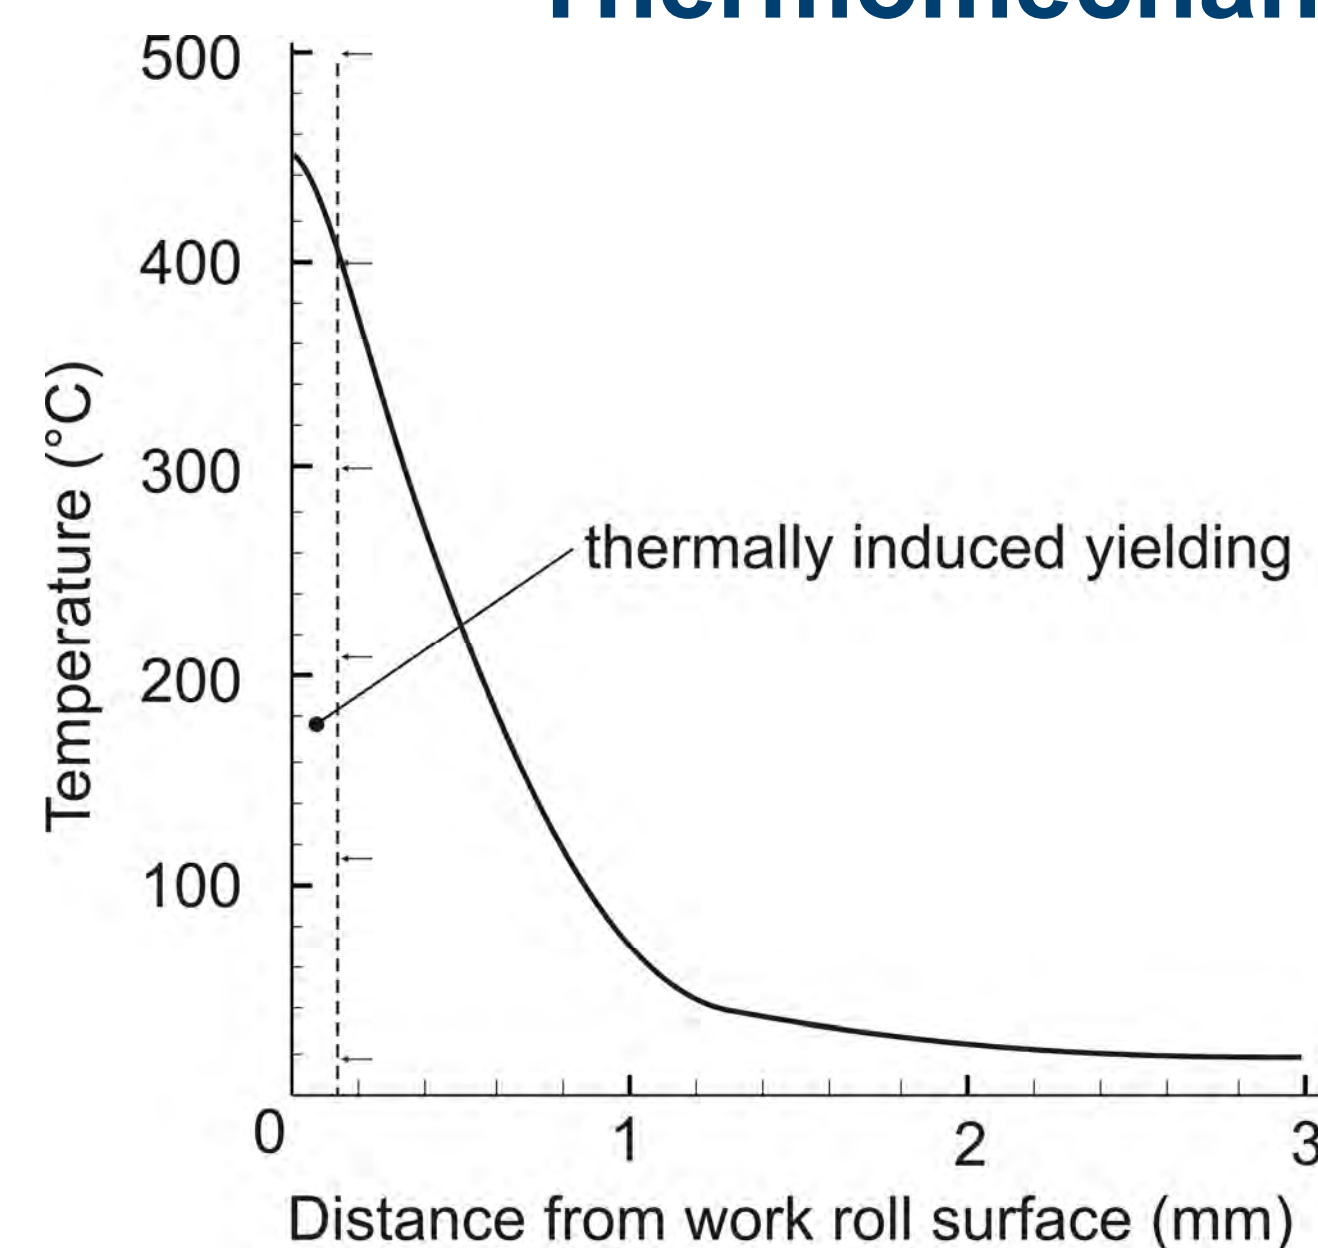
Carbides show only cracks parallel to the roll surface, caused by a compressive load due to the high temperature gradient in the rolling gap. Crack propagation normal to the loading direction is assumed to be driven by tensile loads induced by high temperature gradients during cooling of the roll. Distributed short cracks of carbides and their coalescence with perpendicular cracks in the matrix (firecracks) combined with decohesion are the main failure mechanisms. Firecracks in areas without broken carbides are not critical regarding banding damage. Additionally it can be observed that the maximum thickness of the worn layers does not exceed 100 µm, which corresponds with the extent of the analytically calculated plastic zone.

Analytically obtained temperature profile at the end of the rolling gap. Depth range of thermally induced yielding of the work roll material.

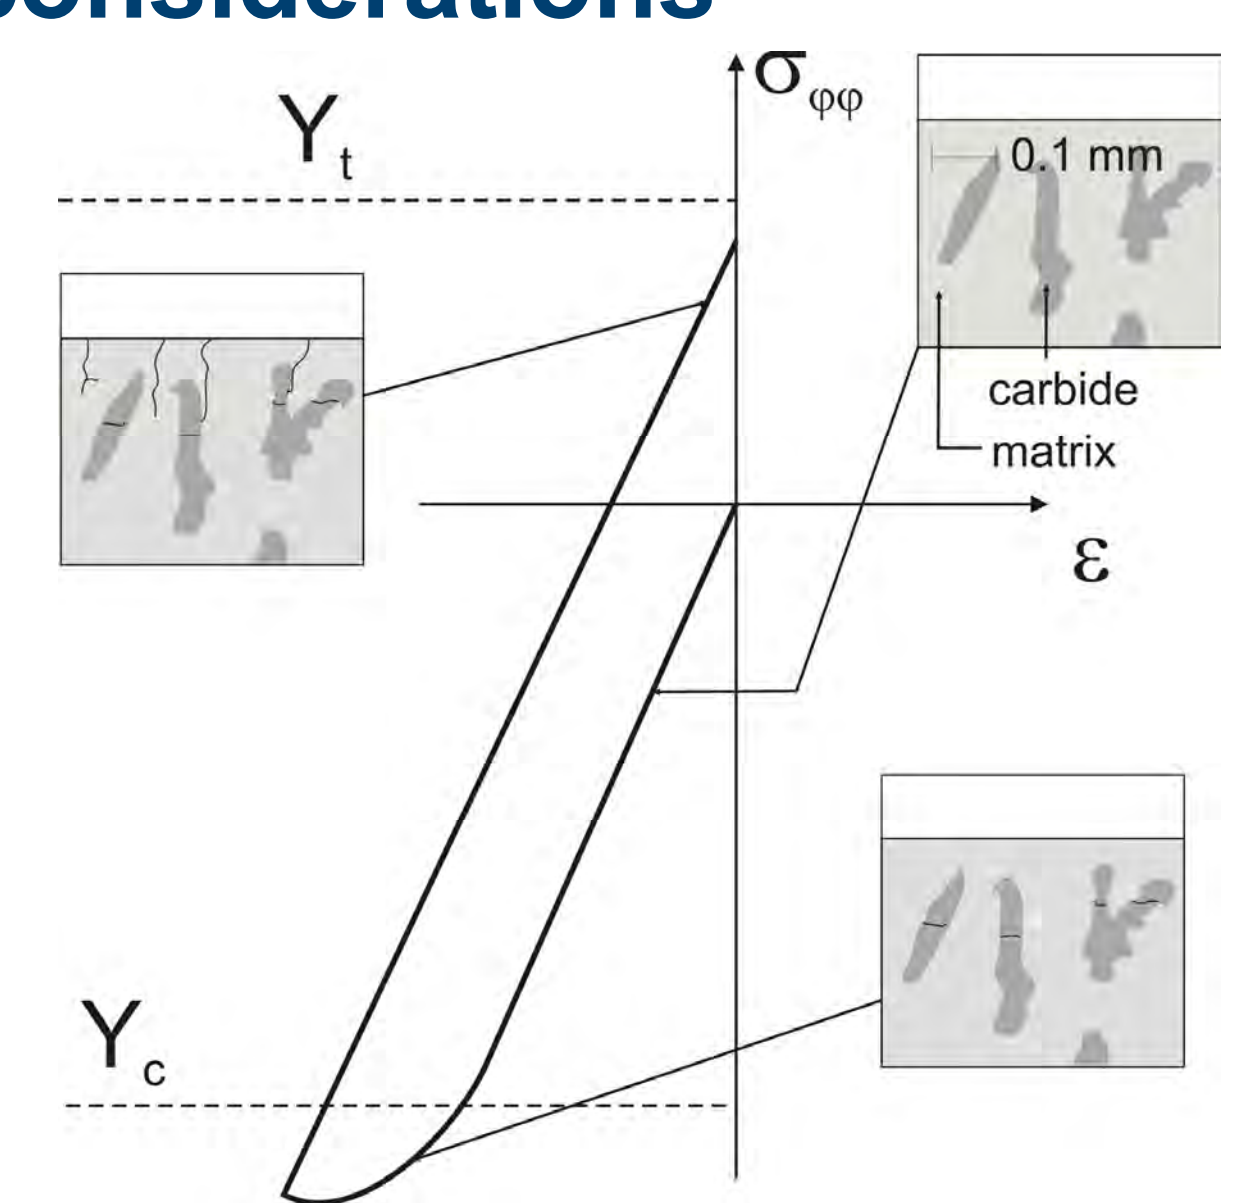
Banding is triggered by cyclic thermal loading and is assumed to occur in areas with a high density of broken carbides. Sufficiently high compressive loads in circumferential direction induce short cracks parallel to the roll surface within carbides. Tensile loads in circumferential direction lead to cracks perpendicular to the surface within the matrix. The damaged layer is separated by adhesion between the strip and the work roll or the back-up roll and the work roll.

Stress-strain curve of one heating / cooling cycle. Depiction of crucial loading states inducing cracks.

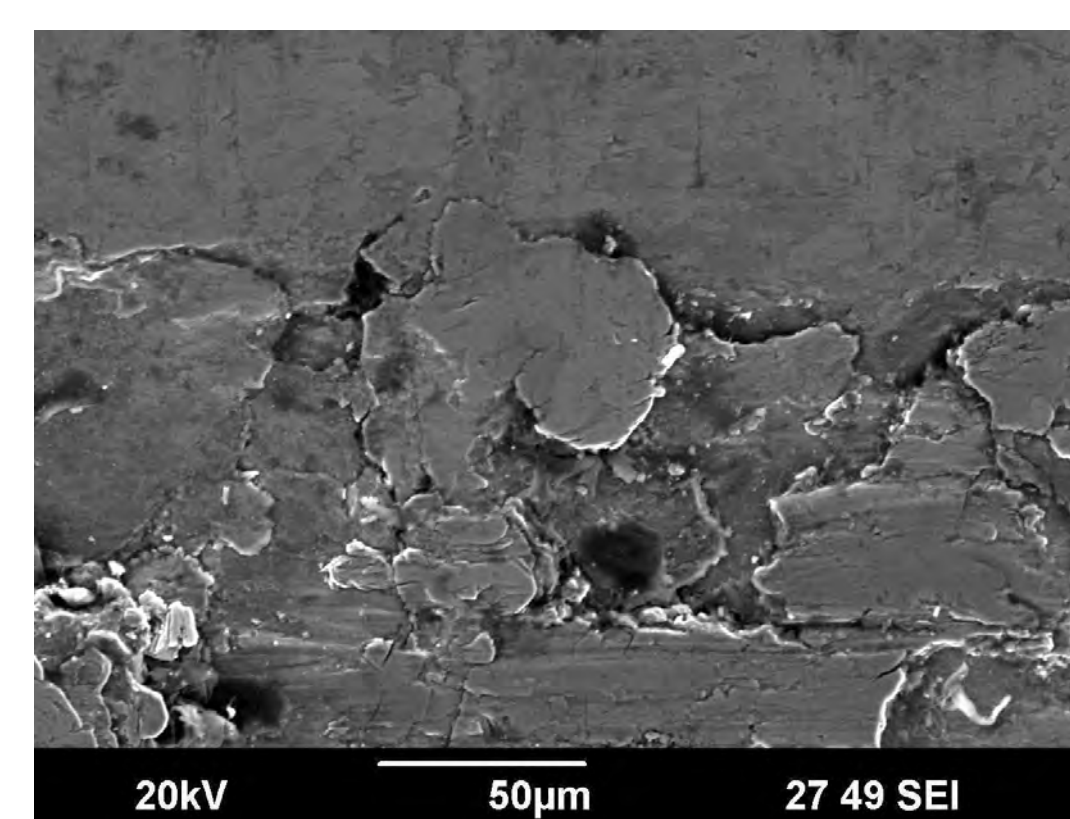
Transition of un-banded and banded area in topview on the roll surface, SEM.

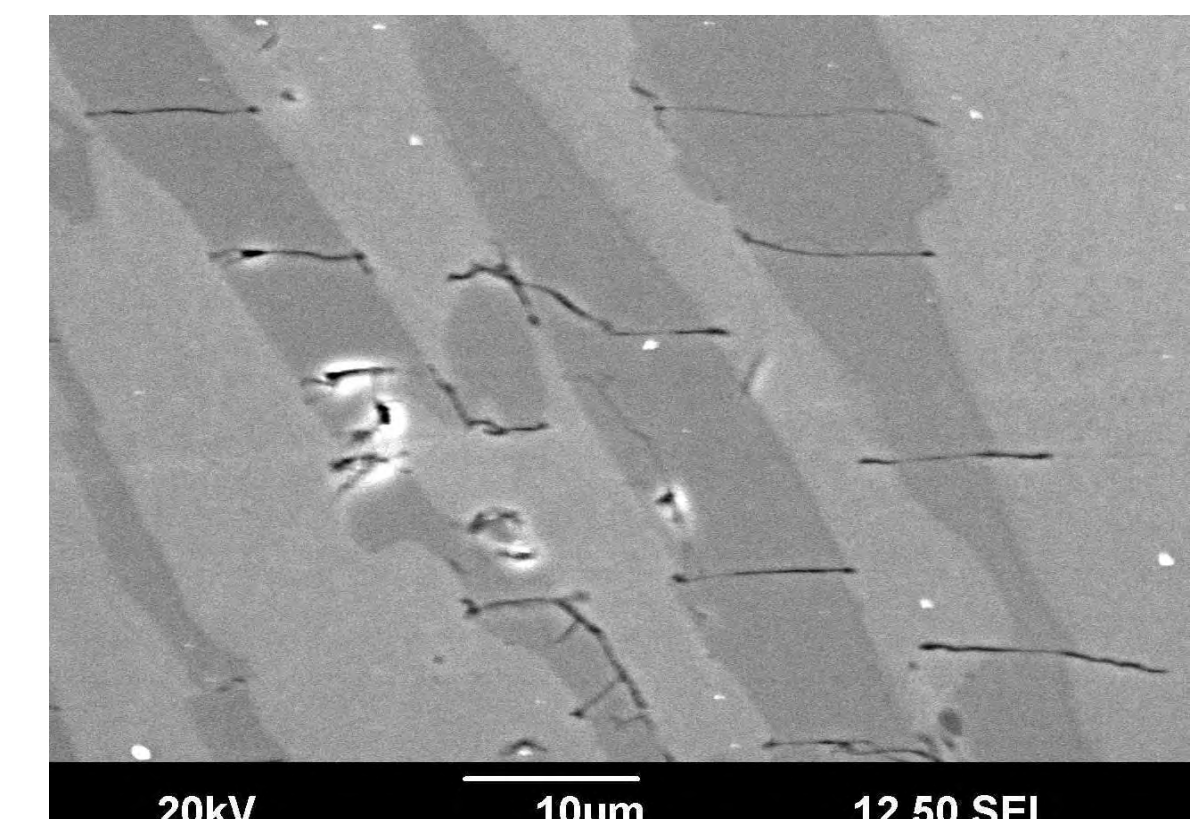
Carbides fractured parallel to the roll surface (dark) and martensitic matrix (light), imaging perpendicular to the roll surface, SEM.

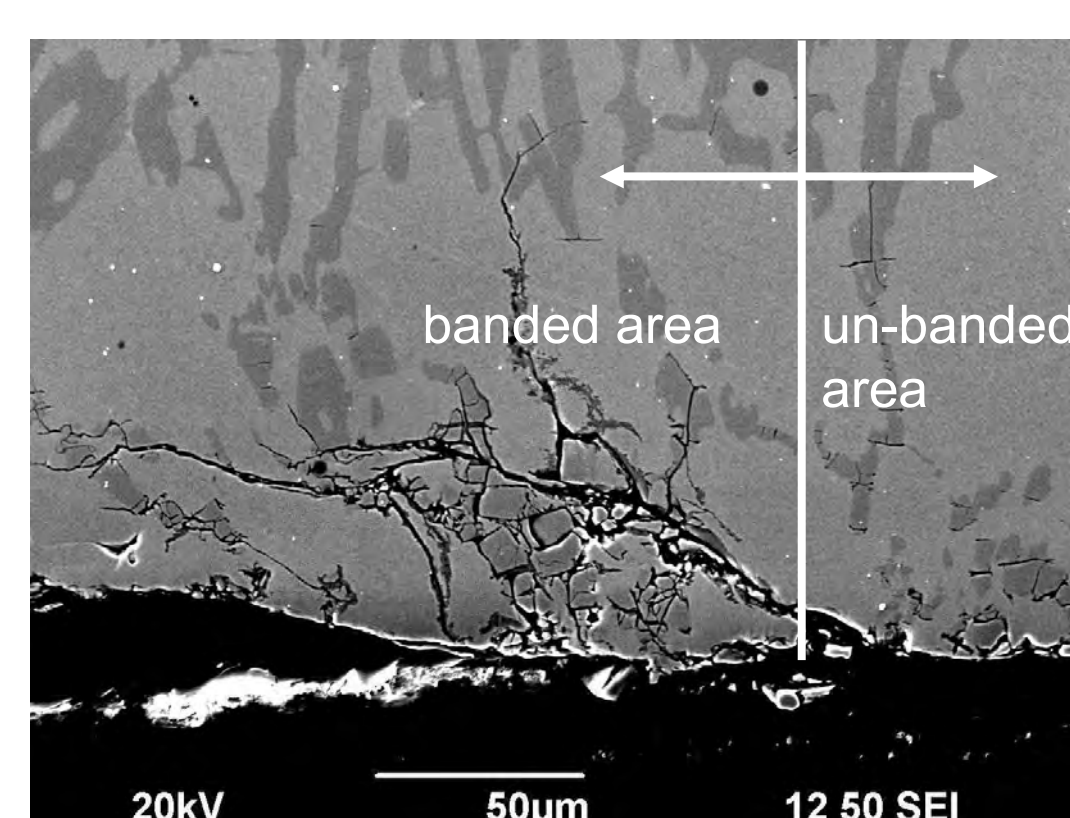
Transition of un-banded and banded area in lateral view, SEM.

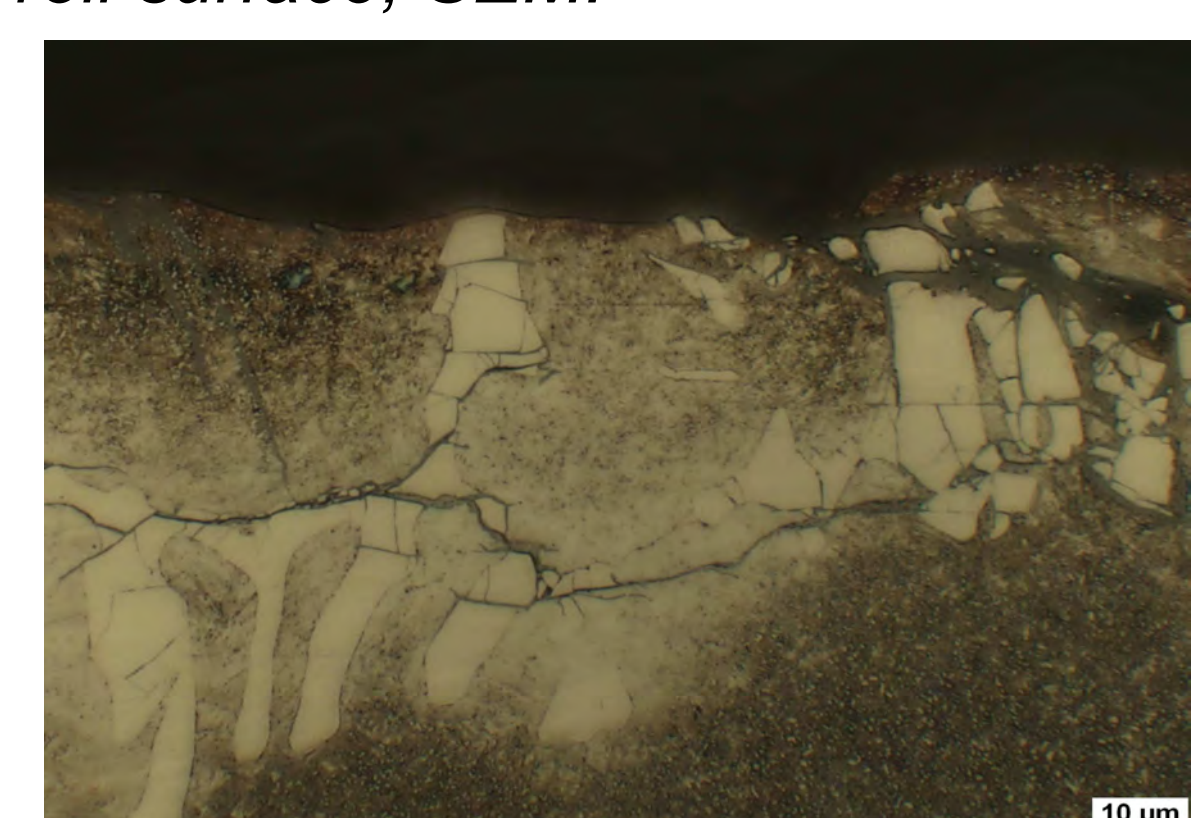
Carbides fractured parallel to the roll surface (light) and martensitic matrix (dark). LOM, Nital etching.
